**Flood Control Project Maintenance
Levee Inspections****LMA District Cover Sheet****Spring 2015 Levee Inspection Results****Sutter Maintenance Yard East Levee Sutter Bypass**

Levee Inspection Report By Mile - Spring 2015

Sutter Maintenance Yard East Levee Sutter Bypass

Waterway	Bank	Unit Miles	Inspection Start/End	Inspector
Unit No. 01 Sutter Bypass Levee	Left	21.77	04/02/2015 04/02/2015	Bob Duffey

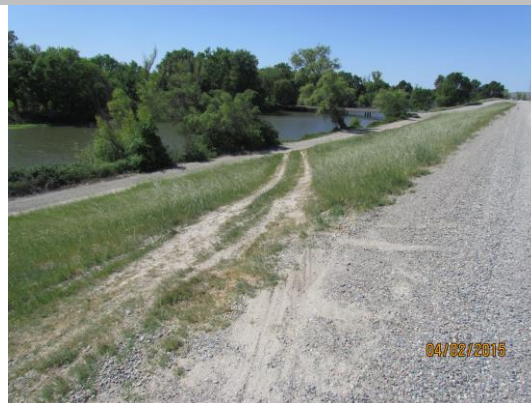
Photo 1 of 1 : SP_2015_ST0002_450_28_20150406_00005.jpg

LM Start	4.46	Rating **	M	Issue No.	28
LM End	4.46	Issue Type +	Ma	Location *	WS
Category	Earthen Levee			GPS Latitude/Longitude	
				Start	End
Item	Slope Stability			39.112042 °	39.112042 °
				-121.766687 °	-121.766687 °
DWR ID	DWR_ST0002_01_s_2015_28				
Action/Comments					
Repair the levee slope damaged by vehicle traffic and prevent access where possible.					
Inspector Comments: Repair the vehicle ersion along the the waterside slope.

View of the vehicle erosion along the waterside slope.

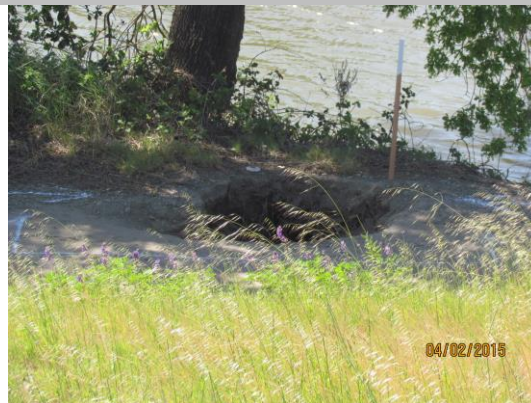
Photo 1 of 1 : SP_2015_ST0002_450_27_20150406_00006.jpg

LM Start	4.78	Rating **	M	Issue No.	27
LM End	4.78	Issue Type +	Ma	Location *	WS
Category	Earthen Levee			GPS Latitude/Longitude	
				Start	End
Item	Erosion / Bank Caving			39.108427 °	39.108427 °
				-121.762910 °	-121.762910 °
DWR ID	DWR_ST0002_01_s_2015_27				
Action/Comments					
Schedule repair of erosion site prior to the next inspection.					
Inspector Comments: Repair the beaver hole at the waterside toe.

View of the beaver hole along the waterside toe.

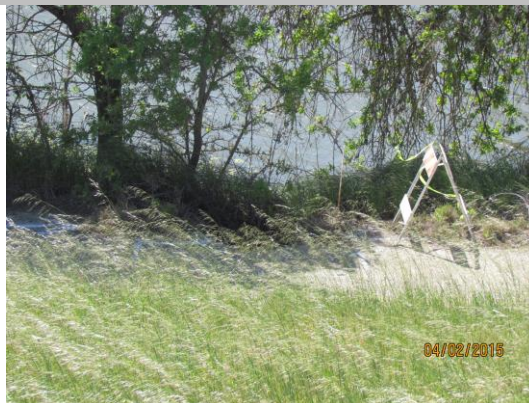
Photo 1 of 1 : SP_2015_ST0002_450_26_20150406_00007.jpg

LM Start	4.95	Rating **	M	Issue No.	26
LM End	4.95	Issue Type +	Ma	Location *	WS
Category	Earthen Levee			GPS Latitude/Longitude	
				Start	End
Item	Erosion / Bank Caving			39.106428 °	39.106428 °
				-121.761150 °	-121.761150 °
DWR ID	DWR_ST0002_01_s _ 2015_26				
Action/Comments					
Schedule repair of erosion site prior to the next inspection.					
Inspector Comments: Repair the beaver hole at the waterside toe.

View of the beaver hole at the waterside toe.

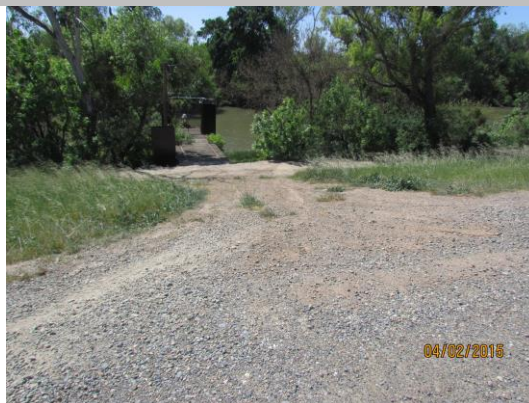
Photo 1 of 1 : SP_2015_ST0002_450_25_20150406_00008.jpg

LM Start	5.20	Rating **	M	Issue No.	25
LM End	5.20	Issue Type +	Ma	Location *	WS
Category	Earthen Levee			GPS Latitude/Longitude	
				Start	End
Item	Slope Stability			39.103313 °	39.103313 °
				-121.758813 °	-121.758813 °
DWR ID	DWR_ST0002_01_s _ 2015_25				
Action/Comments					
Repair the levee slope damaged by vehicle traffic and prevent access where possible.					
Inspector Comments: Repair the vehicle erosion along the waterside slope.

View of the vehicle erosion along the waterside slope.

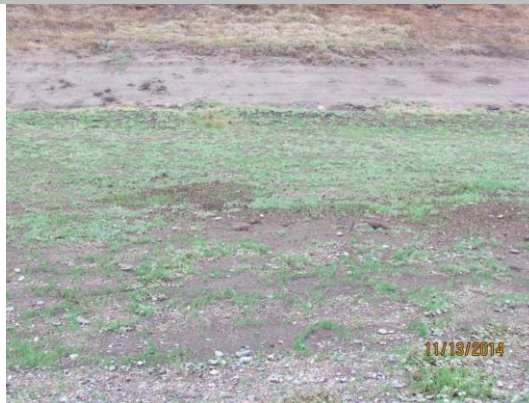
Photo 1 of 1 : SP_2015_ST0002_450_24_20150310_00003.jpg

LM Start	16.23	Rating **	A/W	Issue No.	24
LM End	16.23	Issue Type +	Ma	Location *	LS
Category	Earthen Levee			GPS Latitude/Longitude	
				Start	End
Item	Animal Control			38.965188 °	38.965188 °
				-121.670365 °	-121.670365 °
DWR ID	DWR_ST0002_01_f_2014_24				
Action/Comments					
No rodents visible, but rodent burrows visible; need to backfill and compact or grout burrows.

View of the rodent holes on the landside slope.

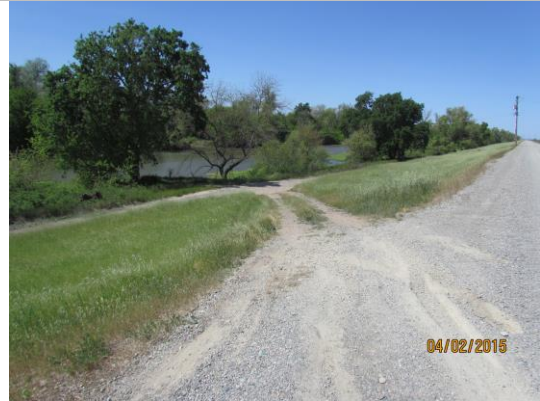
Photo 1 of 1 : SP_2015_ST0002_450_21_20150406_00009.jpg

LM Start	17.60	Rating **	M	Issue No.	21
LM End	17.60	Issue Type +	Ma	Location *	WS
Category	Earthen Levee			GPS Latitude/Longitude	
				Start	End
Item	Slope Stability			38.949965 °	38.949965 °
				-121.653823 °	-121.653823 °
DWR ID	DWR_ST0002_01_s _ 2015_21				
Action/Comments					
Repair the levee slope damaged by vehicle traffic and prevent access where possible.					
Inspector Comments: Repair the vehicle erosion along the waterside slope.

View of the vehicle erosion along the waterside slope.

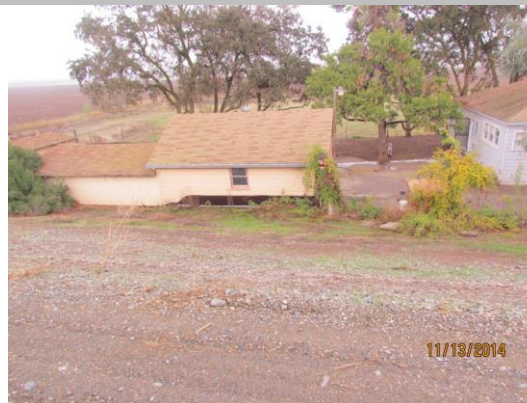
Photo 1 of 1 : SP_2015_ST0002_450_10_20150310_00001.jpg

LM Start	20.34	Rating **	U	Issue No.	10
LM End	20.34	Issue Type +	En	Location *	LS
Category	Earthen Levee			GPS Latitude/Longitude	
				Start	End
Item	Encroachments			38.918147 °	38.918147 °
				-121.624545 °	-121.624545 °
DWR ID	DWR_ST0002_01_s _ 2012_10				
Action/Comments					
Building

View of the house next to the toe of the levee.
